NSWCCD-65-TR-2001/23

Structural Integrity and Damage Evaluation Routine (SIDER) for Quality Control and Health Monitoring of Structures

Subj: COLLABORATIVE STRUCTURAL EVALUATION OF A HIGHWAY COMPOSITE
DECK BRIDGE

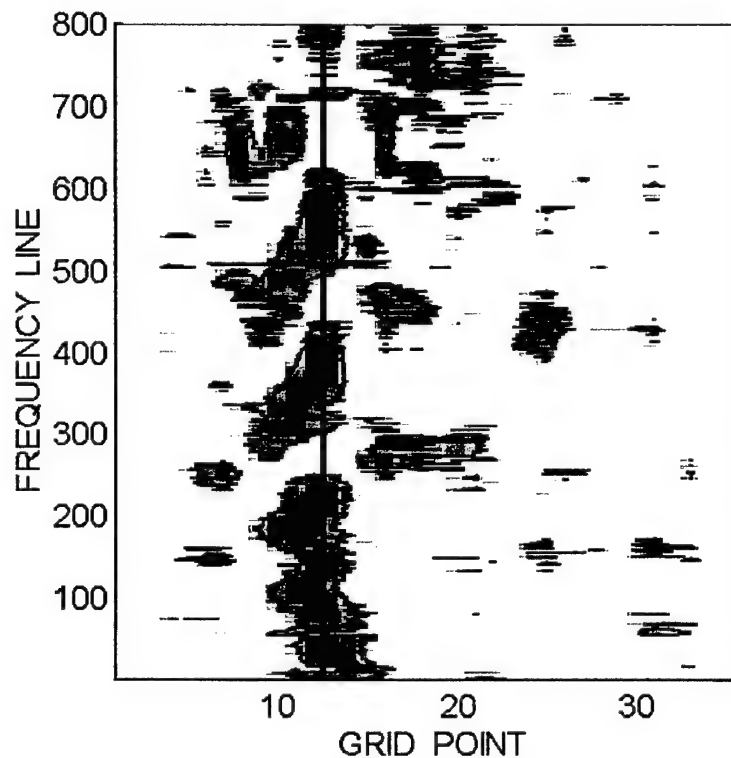
The procedure is repeated separately for every frequency and for every test point on the structure. For a one-dimensional structure (beam), the resulting output can be shown as a contour plot of frequency versus position. Figure 1 shows the results of an experimental BGSM for a 0.914 m long \times 76.2 mm wide \times 6.33 mm thick steel beam with simulated damage created by milling a 0.13-mm deep groove across its width. The resulting damage index plot has a feature which shows consistently at nearly all frequencies at the location of damage (grid point 12.5). It should be noted that one advantage of using the BGSM is that it does not require a footprint of information about a presumably undamaged structure (either finite element or experimental). This means that the BGSM is suited to the inspection of structures that have been in service for some period without a prior inspection.

Figure 1. Experimental Broadband Damage Index for a 6.33-mm Thick Steel Beam with a 2.8-mm wide, 0.13-mm Deep Groove at the Position Marked

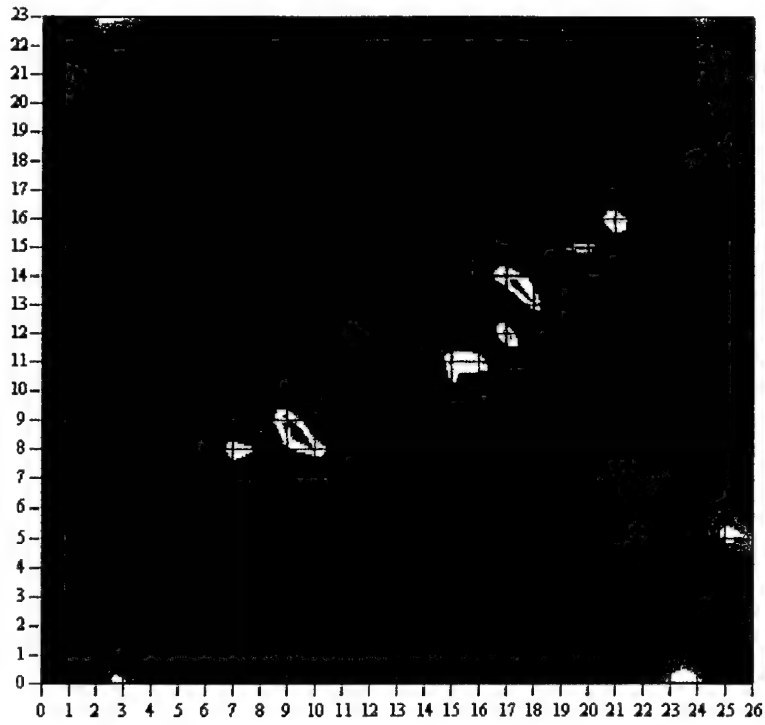
Figure 2 shows the reduced summary plot for one of the foam core panels that was impacted at its center with a 4-inch diameter spherical tup at an energy level of 1344 ft-lbs. The SIDER procedure indicates that, in addition to the damage at the impact site, there is other damage approximately along the diagonals of the panel. After this vibration examination was complete the panel was end-loaded to destruction. The panel failed along the lines identified by the SIDER analysis.

Figure 2. SIDER Summary Plot for Foam Panel after Impact at 1344 ft-lbs

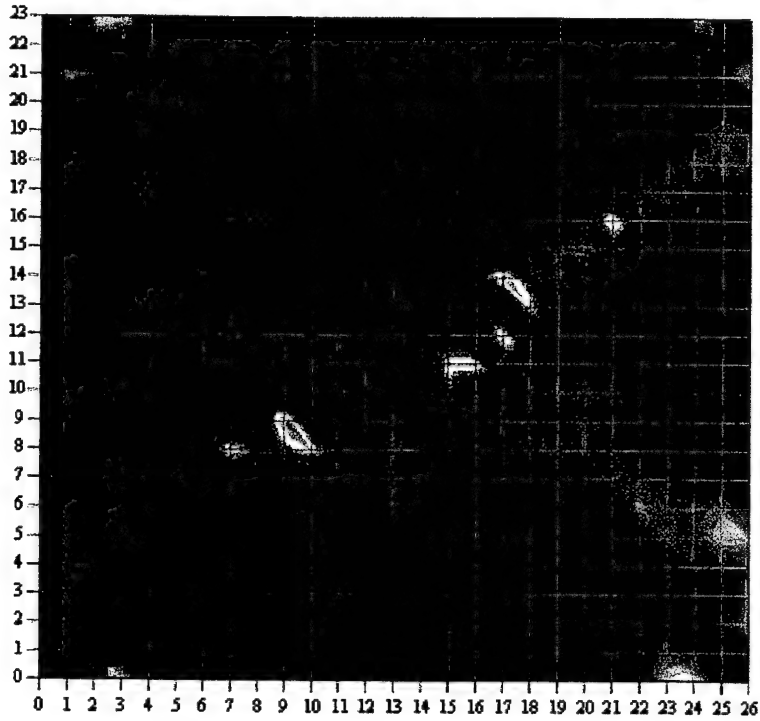
Figures 4 and 5 show the same information as Figures 2 and 3, but after statistical enhancement. The damage on the impacted panel is much easier to interpret, and the plot for the undamaged panel is much ‘cleaner’.

Figure 4. Enhanced Plot for Damaged Foam Panel
